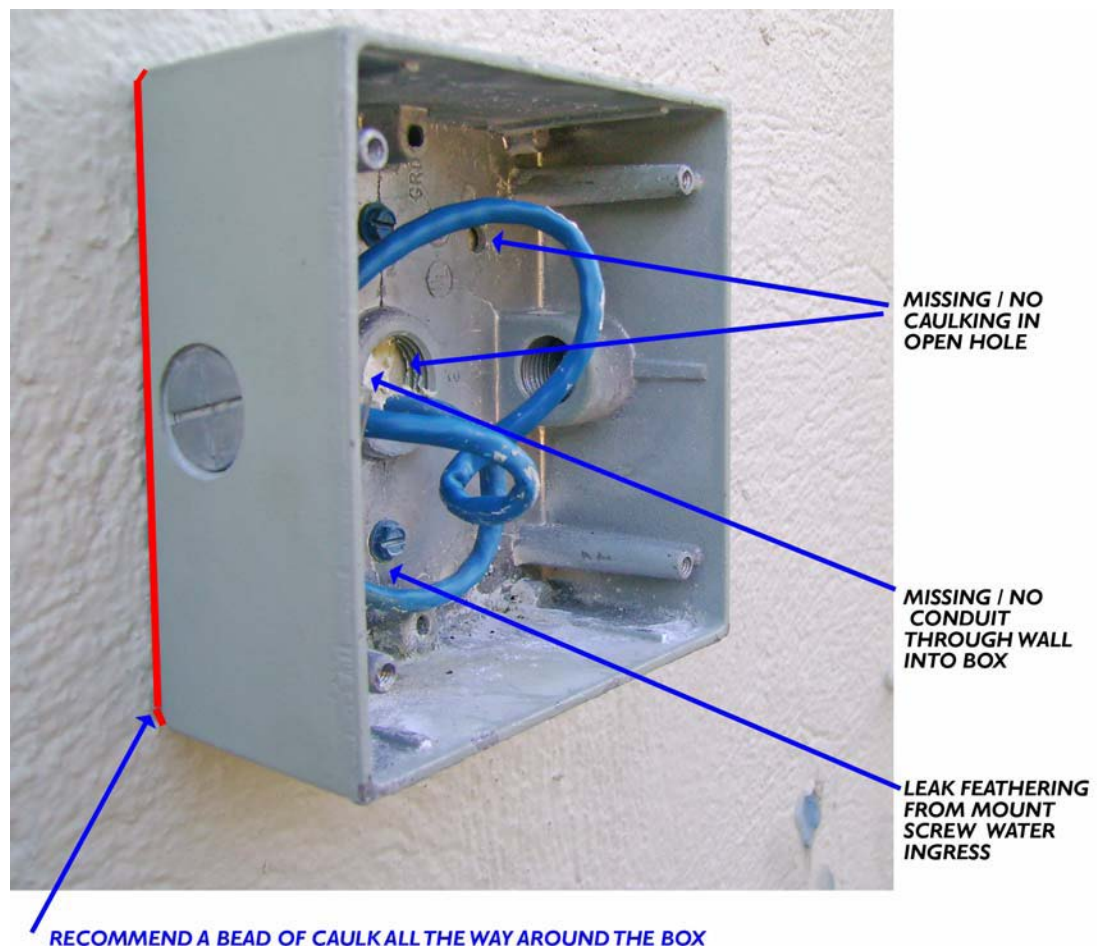
The following installation errors are identified in [Figure 1](#).

1. The conduit was not used to route the wiring through the wall into the box. Consequently, this leaves a large hole in the back of the box which allows water inside of the box.
2. Extra mounting screw holes were drilled in the back of the box, but the holes were not caulked to seal them when they were not used. Also, the mounting holes that were used were not caulked prior to inserting the screws.
3. Due to the texture of the wall and the nature of the mounting box, if any holes made in the box are left unplugged, or not sealed properly, water can get inside of the box. In the situation of this particular box in [Figure 1](#), CyberData recommends a bead of caulk / sealant all the way around the perimeter where the box joins the wall to keep water from coming down the wall and entering through the openings in the back of the box.

Figure 1. VoIP Intercom Installation Errors

Note Make sure that the way the box is mounted does NOT allow water to enter from the back of the box. CyberData recommends that the installation of the intercom be done by a certified electrician to make sure that the Intercom is mounted properly.
